Longboat Key Canal Maintenance Program

Canal Sheets
June 2024

Developed by First Line Coastal alongside the Town of
Longboat Key Public Works Department

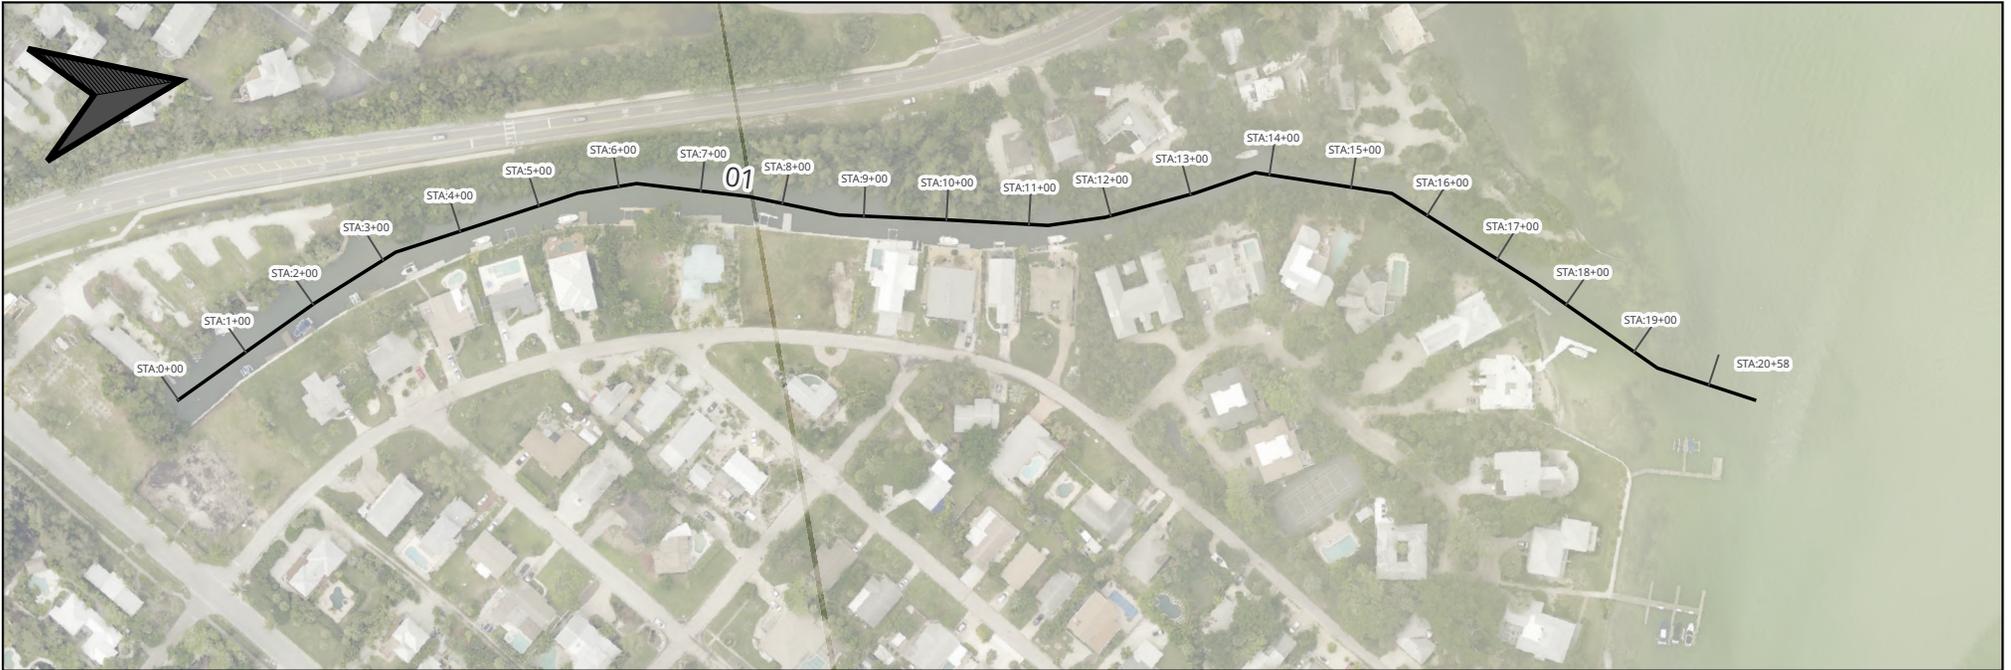
Canal 01

Noted Damage to Structures: Yes - Bowing Seawalls

Limiting Depth at last Survey: -2 ft MLW at STA 16+84

Maintained Width: 20 FT
 Maintained Depth: -4.00 MLW
 Monitoring Frequency: 1 year
 Dredging Required: Yes
 Min Dredge Target: -3.75 MLW
 Number of Segments: Determine during future project
 Dredge Length: Determine during future project
 Additional Work: Mangrove trimming, consider advanced maintenance at mouth in the future

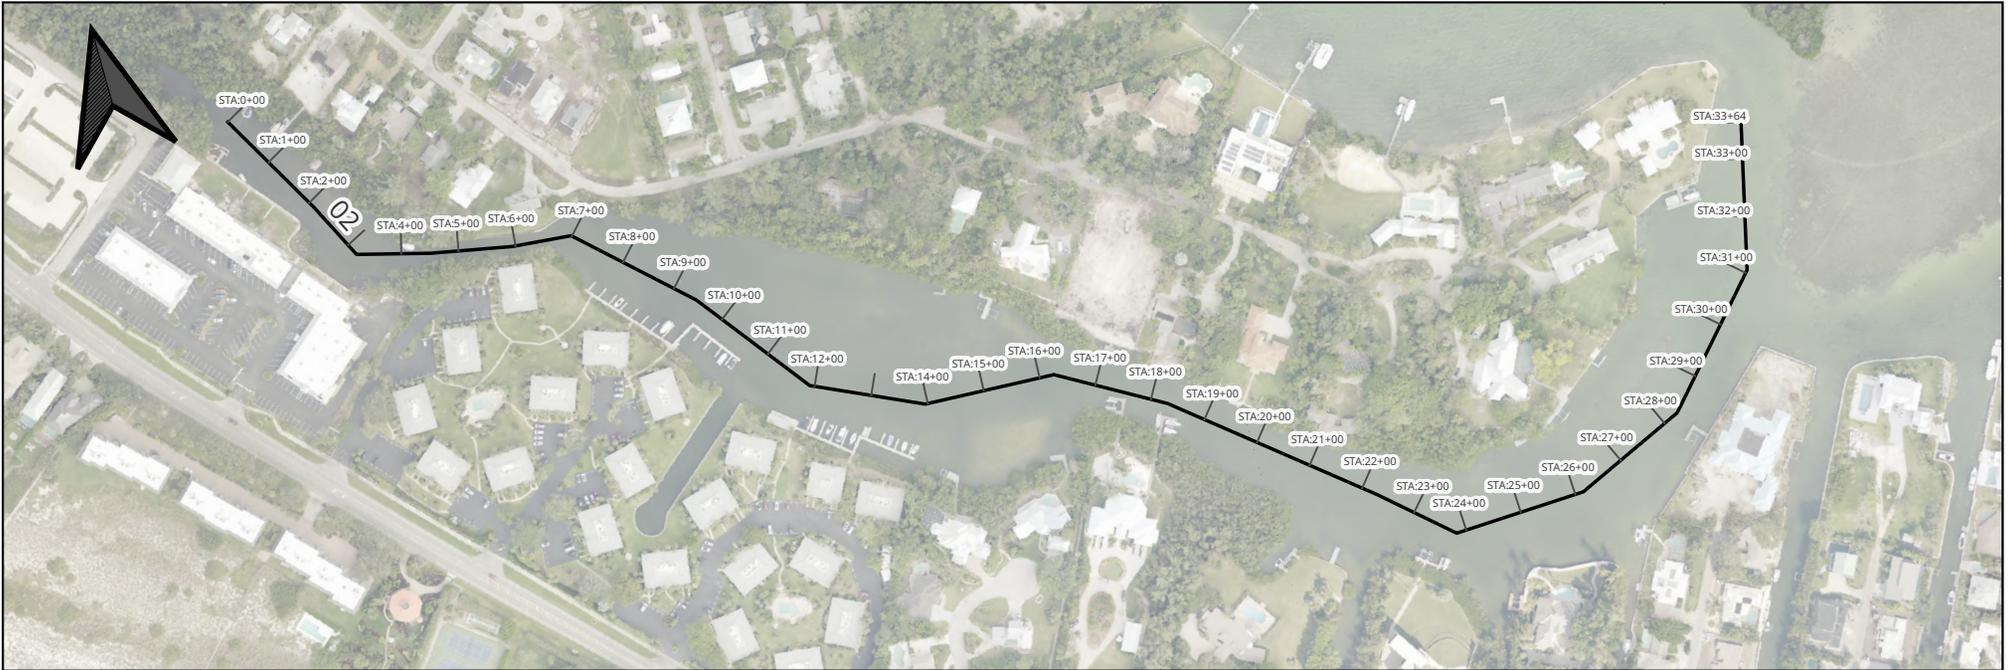
Canal 02

Notes: Green Marker 7 missing

Maintained Width: 20 FT
 Maintained Depth: -5.00 MLW
 Monitoring Frequency: 1 year
 Dredging Required: Yes
 Min Dredge Target: -4.75 MLW
 Number of Segments: Determine during future project
 Dredge Length: Determine during future project
 Additional Work: Mangrove trimming, consider additional ATONS in the future

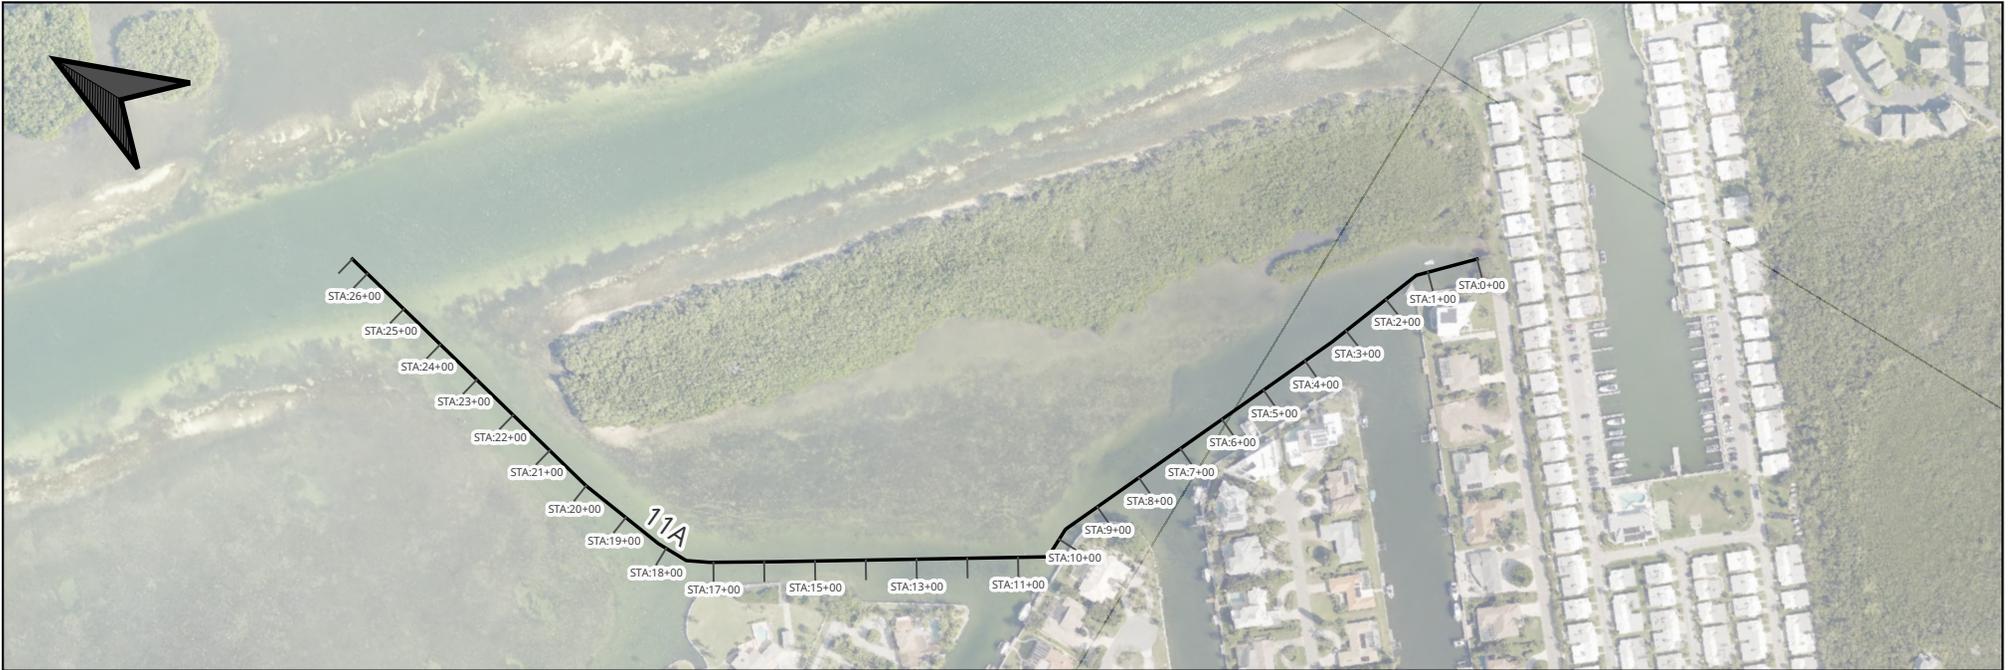
Canal 11A

Notes: Recommend adjusting most inbound marker location (Southeastern most)

Maintained Width: 20 FT
 Maintained Depth: -5.00 MLW
 Monitoring Frequency: 2 years
 Dredging Required: None
 Min Dredge Target: -4.75 MLW
 Number of Segments: 0

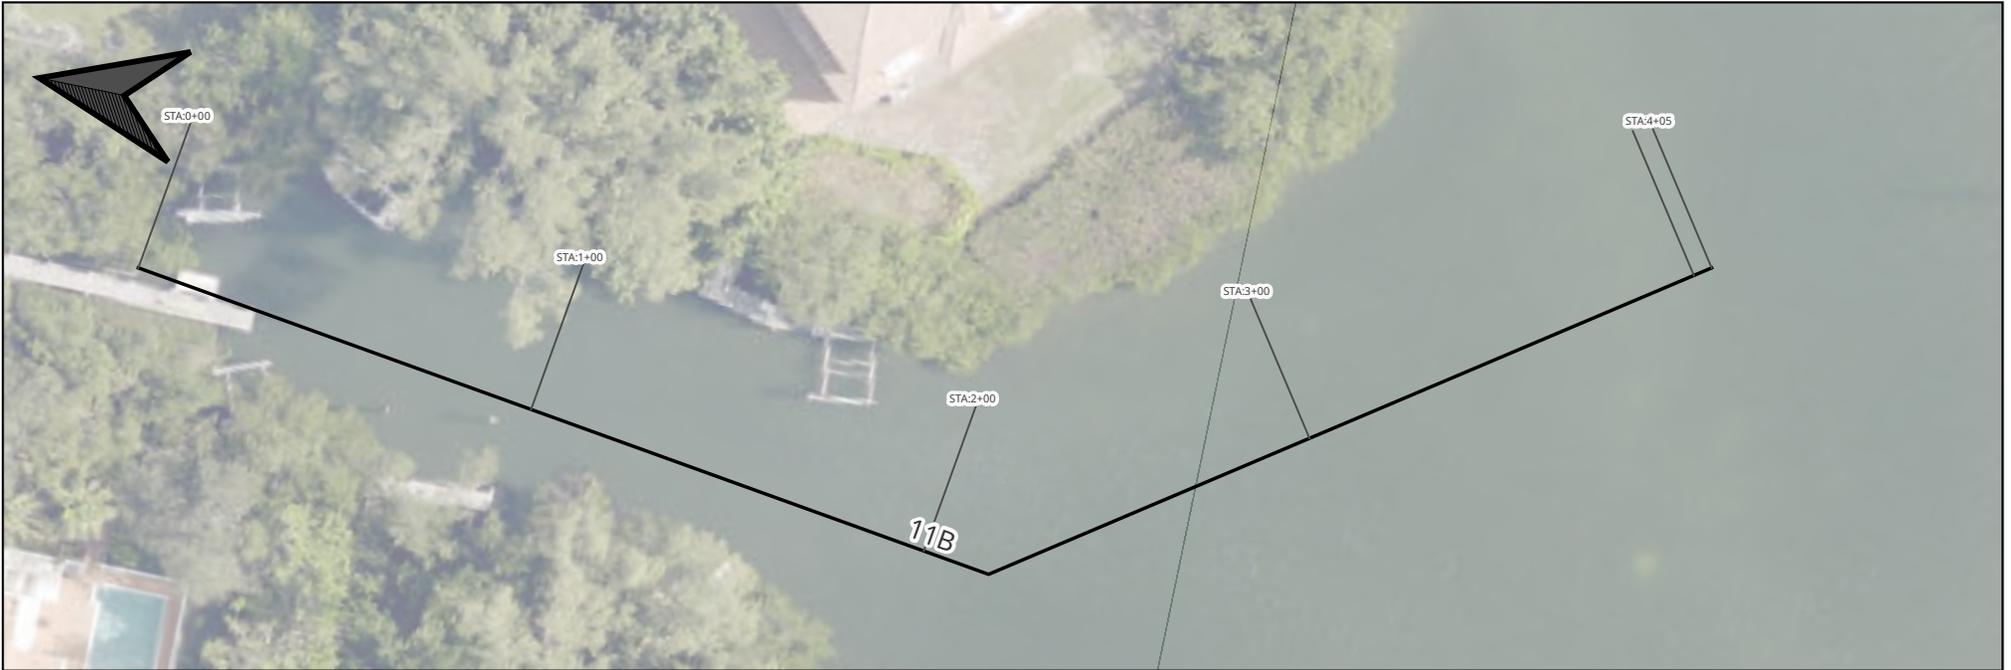
Canal 11B

Primary Usage: Mooring/Dockage Avg Vessel Beam: 7 - 10 ft
 Density of Water Access: 60% Avg Vessel Draft: 2 - 4 ft
 Noted Damage to Structures: No Mapped Seagrass: None
 Notable Exposures: None Mapped
 Impediments: None

Maintained Width: 20 FT
 Maintained Depth: -5.00 MLW
 Monitoring Frequency: 2 years
 Dredging Required: None
 Min Dredge Target: -4.75 MLW
 Number of Segments: 0
 Dredge Length: 0 FT
 Additional Work: Could alter alignment for more gradual transition between 11 and 11B

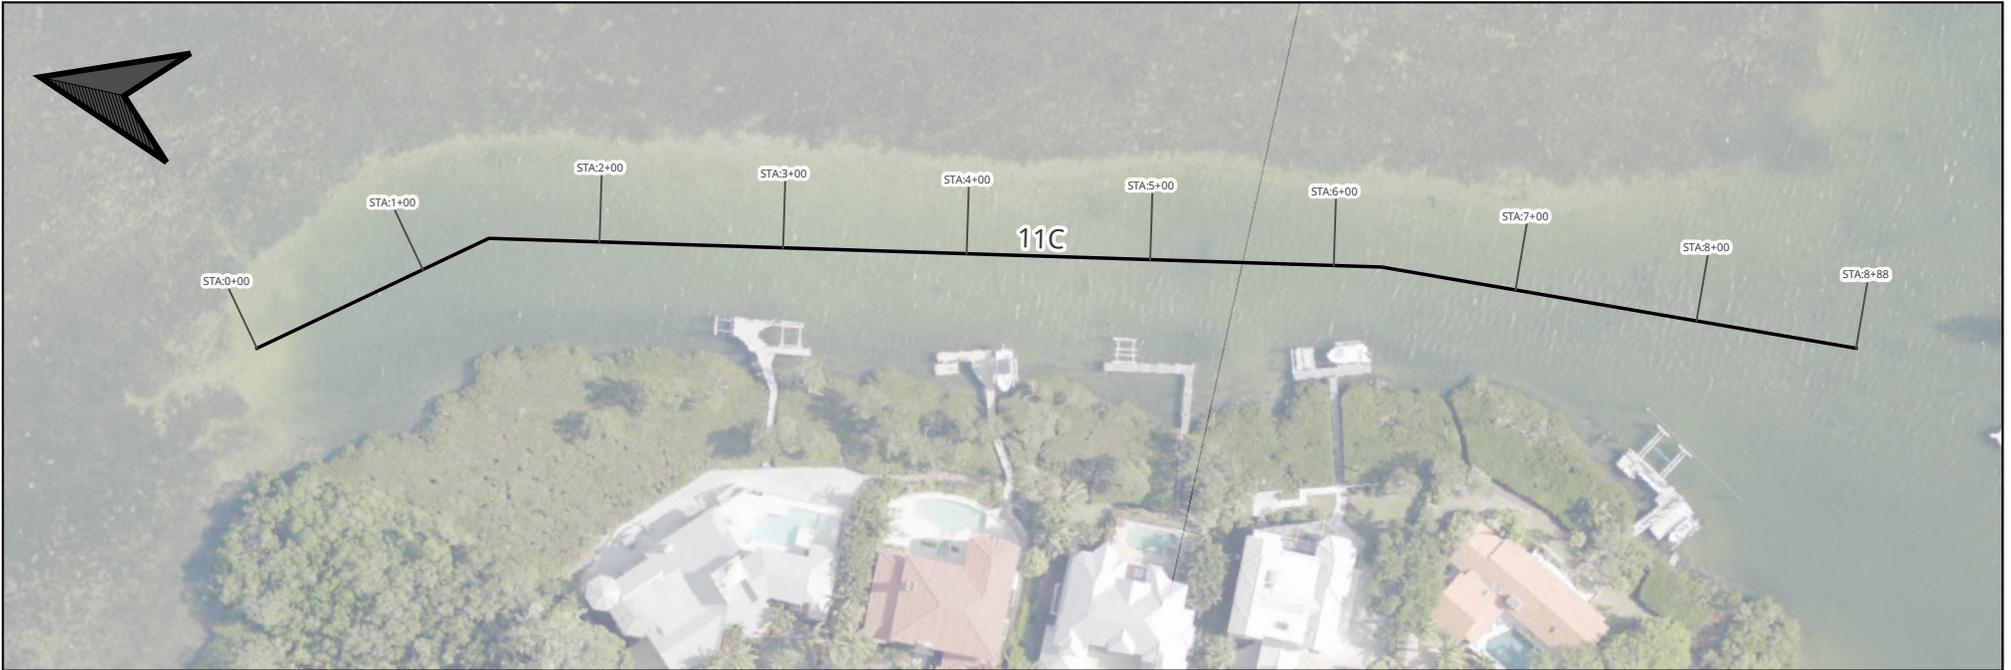
Canal 11C

Primary Usage: Mooring/Dockage Avg Vessel Beam: 7 - 10 ft
 Density of Water Access: 60% Avg Vessel Draft: 2 - 4 ft
 Noted Damage to Structures: No Mapped Seagrass: None
 Notable Exposures: Waves, Wind Mapped
 Impediments: None

Maintained Width: 20 FT
 Maintained Depth: -5.00 MLW
 Monitoring Frequency: 2 years
 Dredging Required: None
 Min Dredge Target: -4.75 MLW
 Number of Segments: 0
 Dredge Length: 0 FT
 Additional Work: Channel between 0+00 and 2+00 should not be maintained

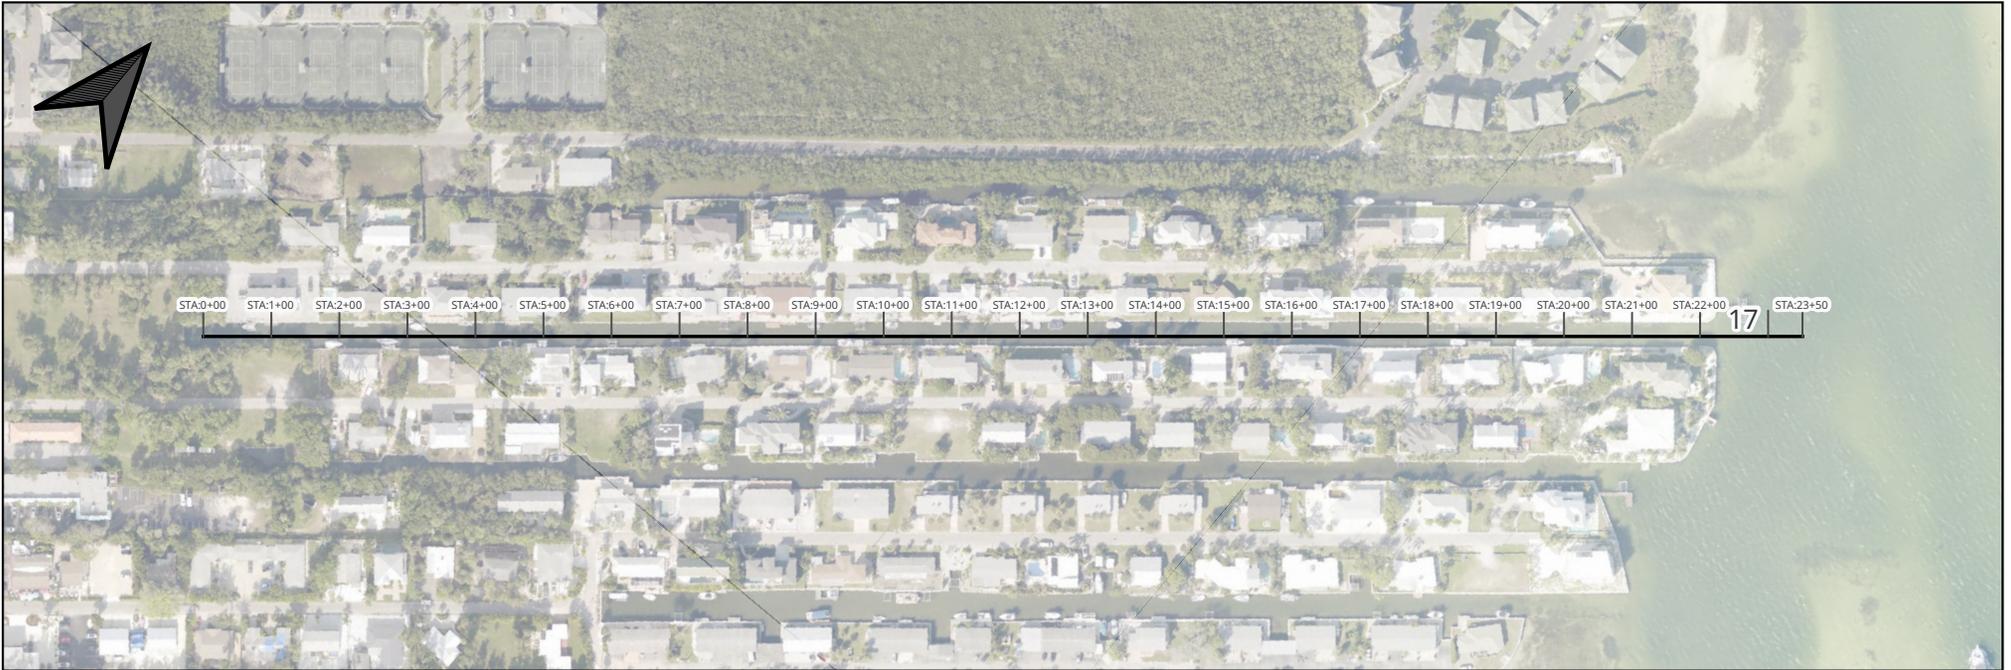
Canal 17

<u>Vessel</u>	<u>Transiting</u>
Length: 24 ft	C - local knowledge
Beam: 9 ft	
Draft: 3.5 ft	
	<u>Meeting</u>
	D - Conditionally Restricted
	<u>Maneuvering</u>
	F - Not Navigable

Noted Damage to Structures: Yes - Bowing Seawalls

Maintained Width: 10 FT
 Maintained Depth: -3.00 MLW
 Monitoring Frequency: 1 year
 Dredging Required: None
 Min Dredge Target: -2.75 MLW
 Number of Segments: 0
 Dredge Length: 0 FT
 Additional Work: Recommend expanding to 4 ft depth during future projects

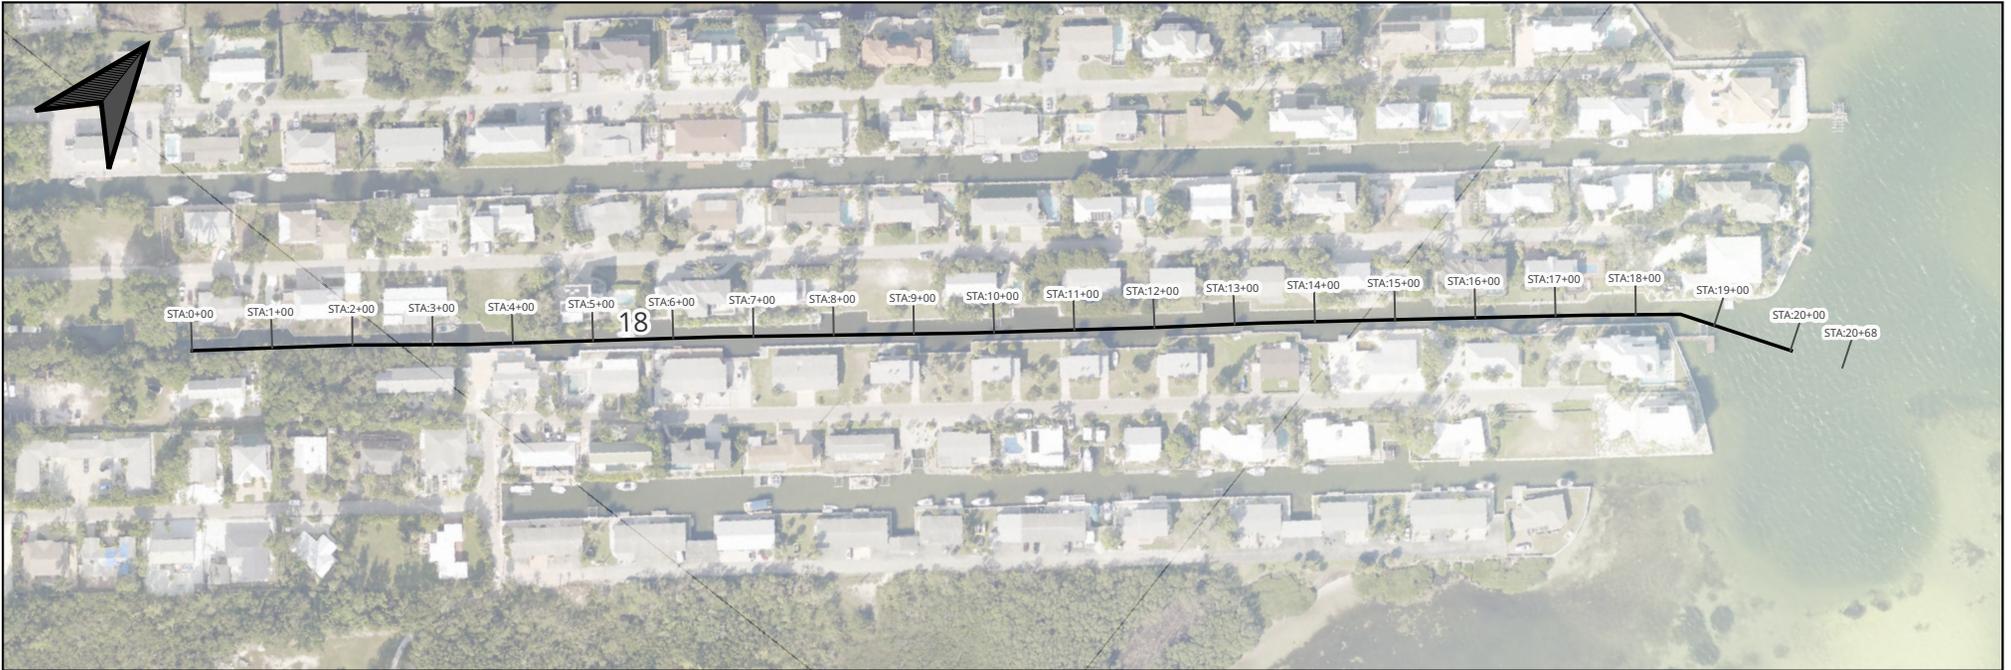
Canal 18

<u>Vessel</u>	<u>Transiting</u>
Length: 24 ft	B - As expected
Beam: 9 ft	
Draft: 3.5 ft	
	<u>Meeting</u>
	D - Conditionally Restricted
	<u>Maneuvering</u>
	F - Not Navigable

Maintained Width: 10 FT
 Maintained Depth: -3.00 MLW
 Monitoring Frequency: 1 year
 Dredging Required: Yes
 Min Dredge Target: -2.75 MLW
 Number of Segments: Determine during future project
 Dredge Length: Determine during future project
 Additional Work: Recommend expanding maintained width at "basins" to improve meeting and docking ability
